Preliminary Prospectus

Utah Department of Transportation

Prepared as part of UDOT Project No. S-R 399(12)

July 2008

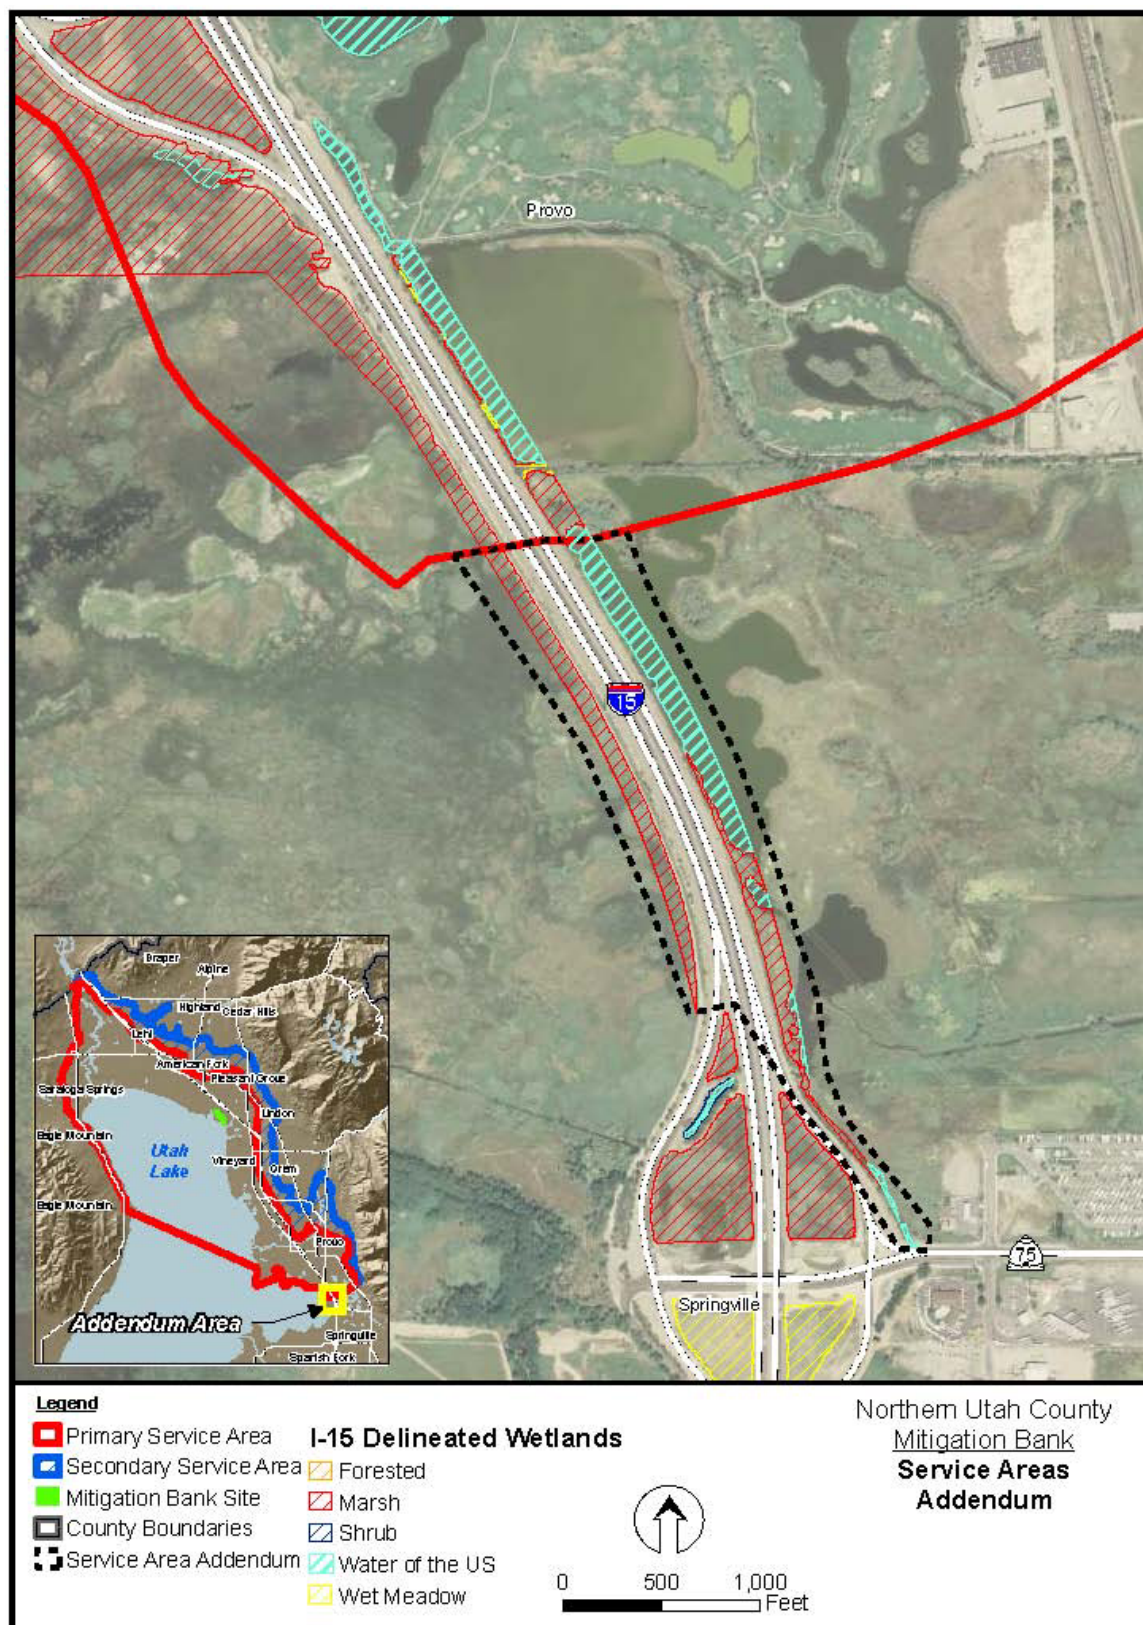
Figure 2. Bank Service Areas Addendum

The proposed GSA has been amended south of the original southern boundary east of Utah Lake (Provo River Hydrological Unit). This additional area added to

the GSA will provide mitigation for all functions and services of a contiguous section of wetlands adjacent to I-15 (see Figure 2).

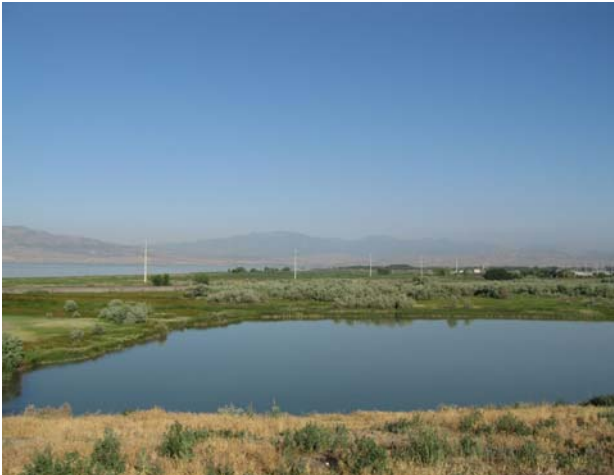
Photo 4: Overlooking the open water pond and south end of the Bank site from the top of the landfill.

The proposed Bank site consists of undeveloped land within 1/4 mile of the western shore of Utah Lake. The site supports palustrine forested, palustrine scrub shrub, and palustrine emergent marsh wetlands, uplands and an open water pond (see Photos 4 and 5).

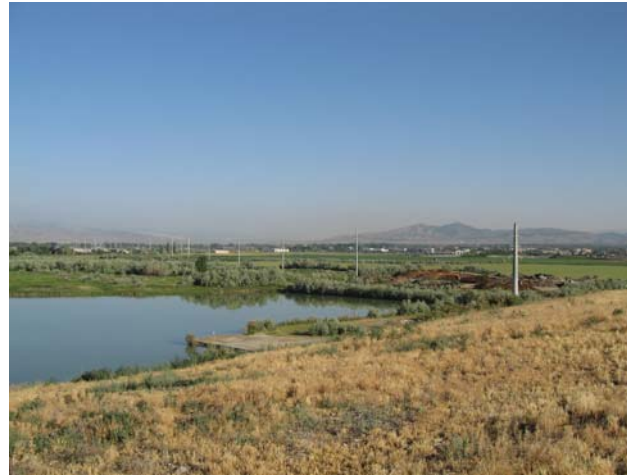
Photo 5: Overlooking the southern 2/3 of the site from the top of the landfill.

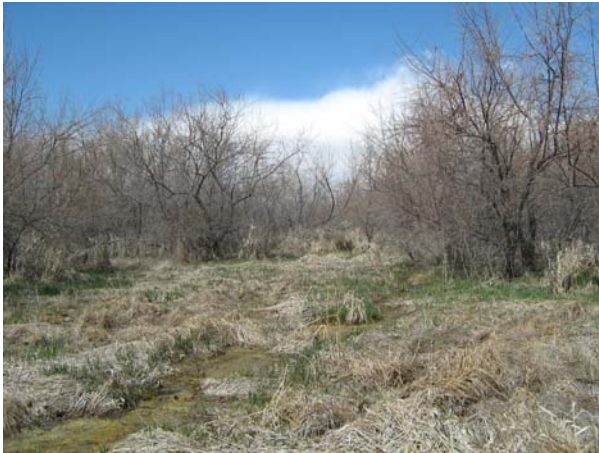
Photo 6: Palustrine forested and palustrine emergent marsh communities on the southern end of the Lindon Bank Site.

- The dominant plant species in the palustrine forested community is Russian olive; Russian olive saplings are the dominant species in the palustrine scrub shrub community; reed canarygrass, salt grass, and bulrush dominant the palustrine emergent marsh community on the site (see Photos 6 – 9).

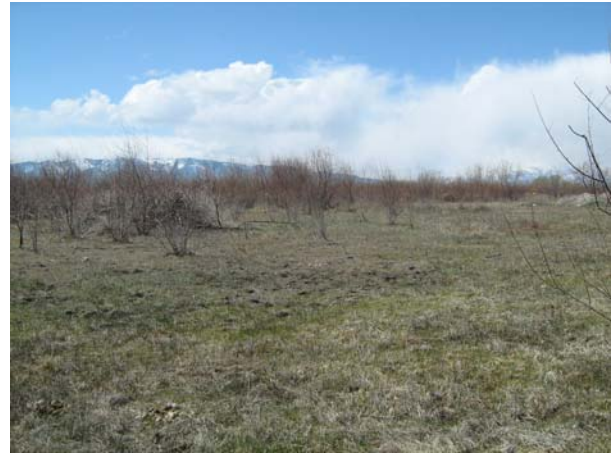
Photo 7: Wetland functions and services will be restored/enhanced in the drier portions of the site.

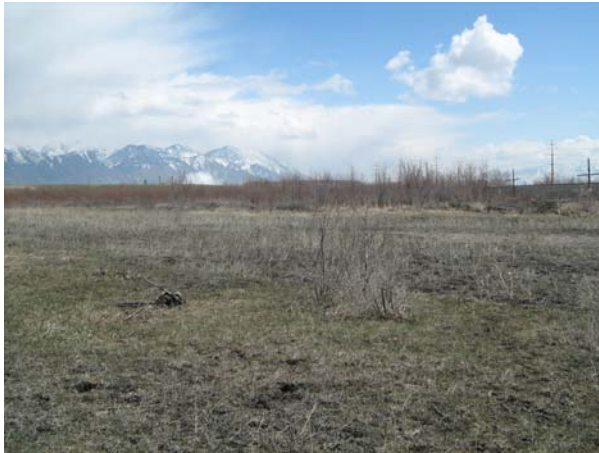
Photo 8: Upland portions of the site will be restored to wetland.

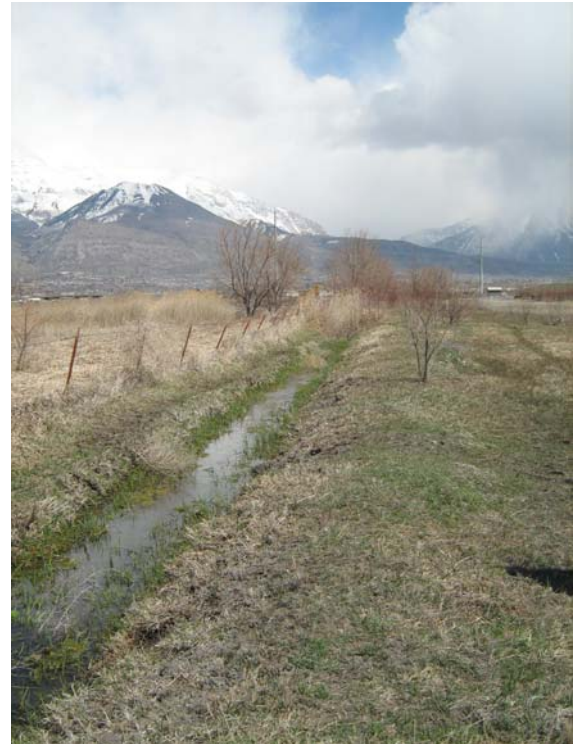
Photo 9: Water moves through the Bank site in a series of ditches.

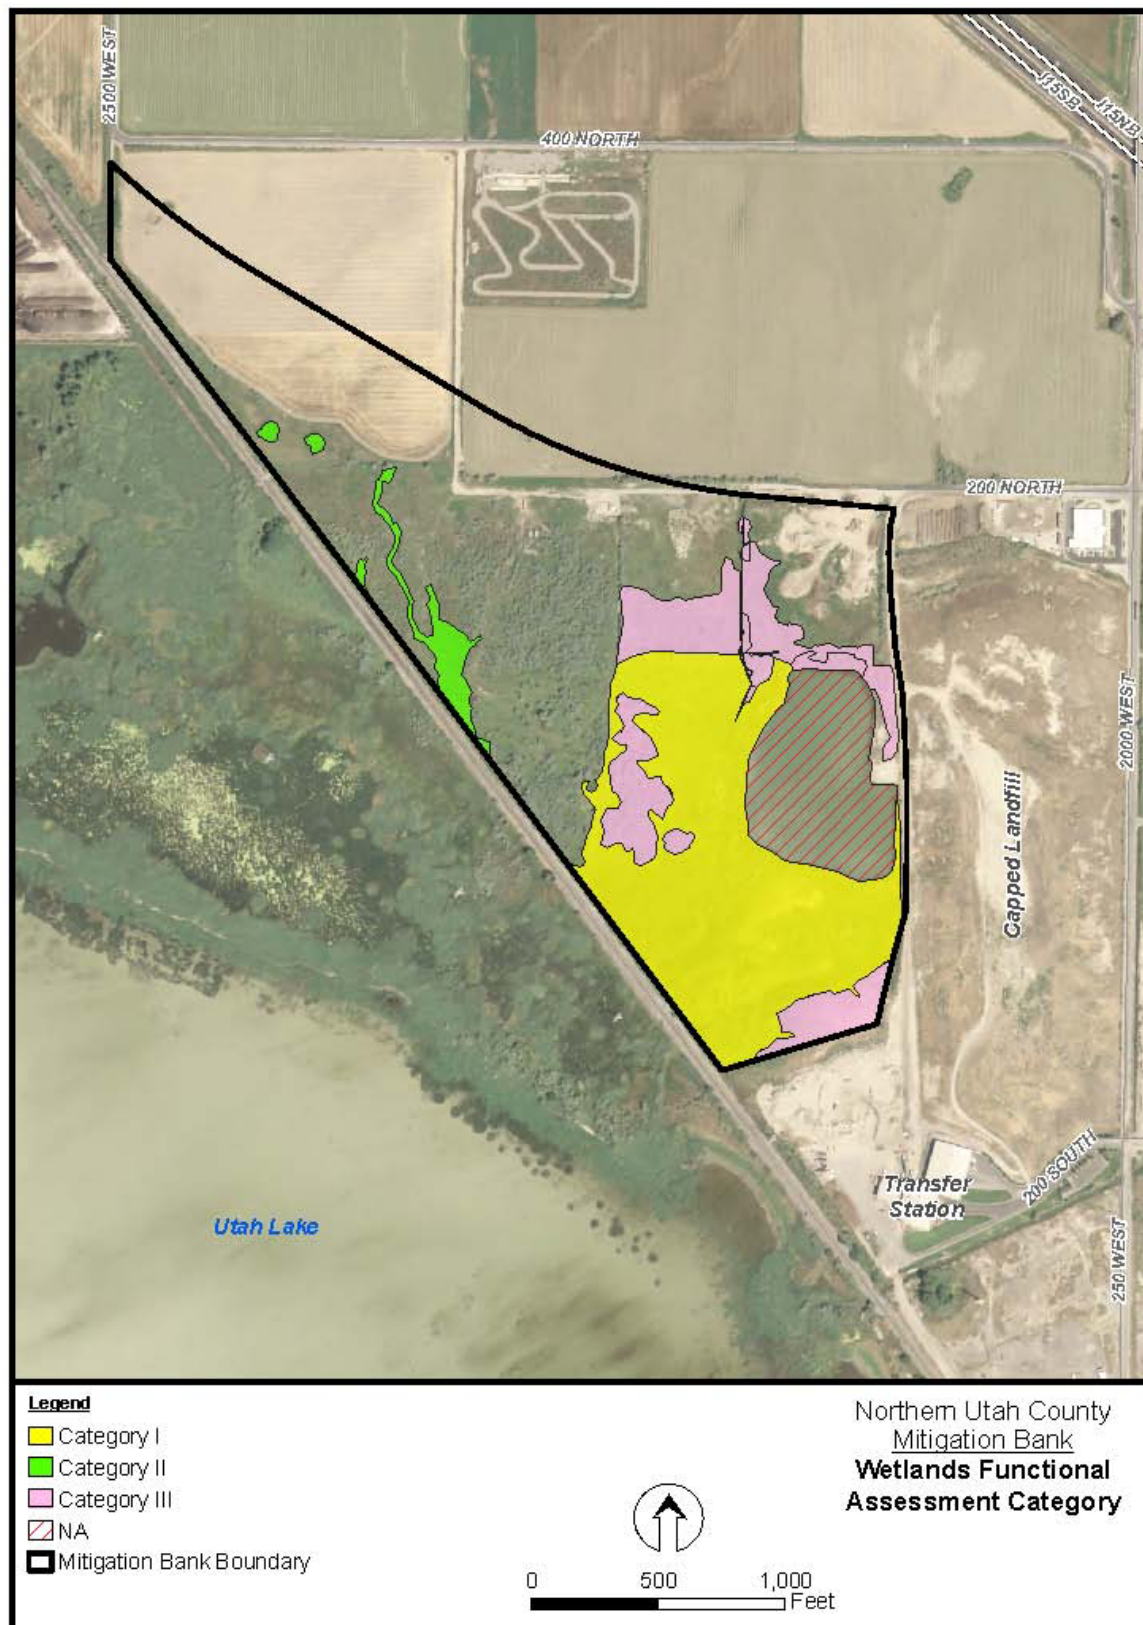
Figure 5. Wetland Functional Assessment Category

According to the UDOT Wetland Functional Assessment, the wetlands found within the Bank site are classified as Category I, II, and III.

Table 8-1 below lists the wetland functional assessment rating. Figure 5 below shows the wetlands by category classification.

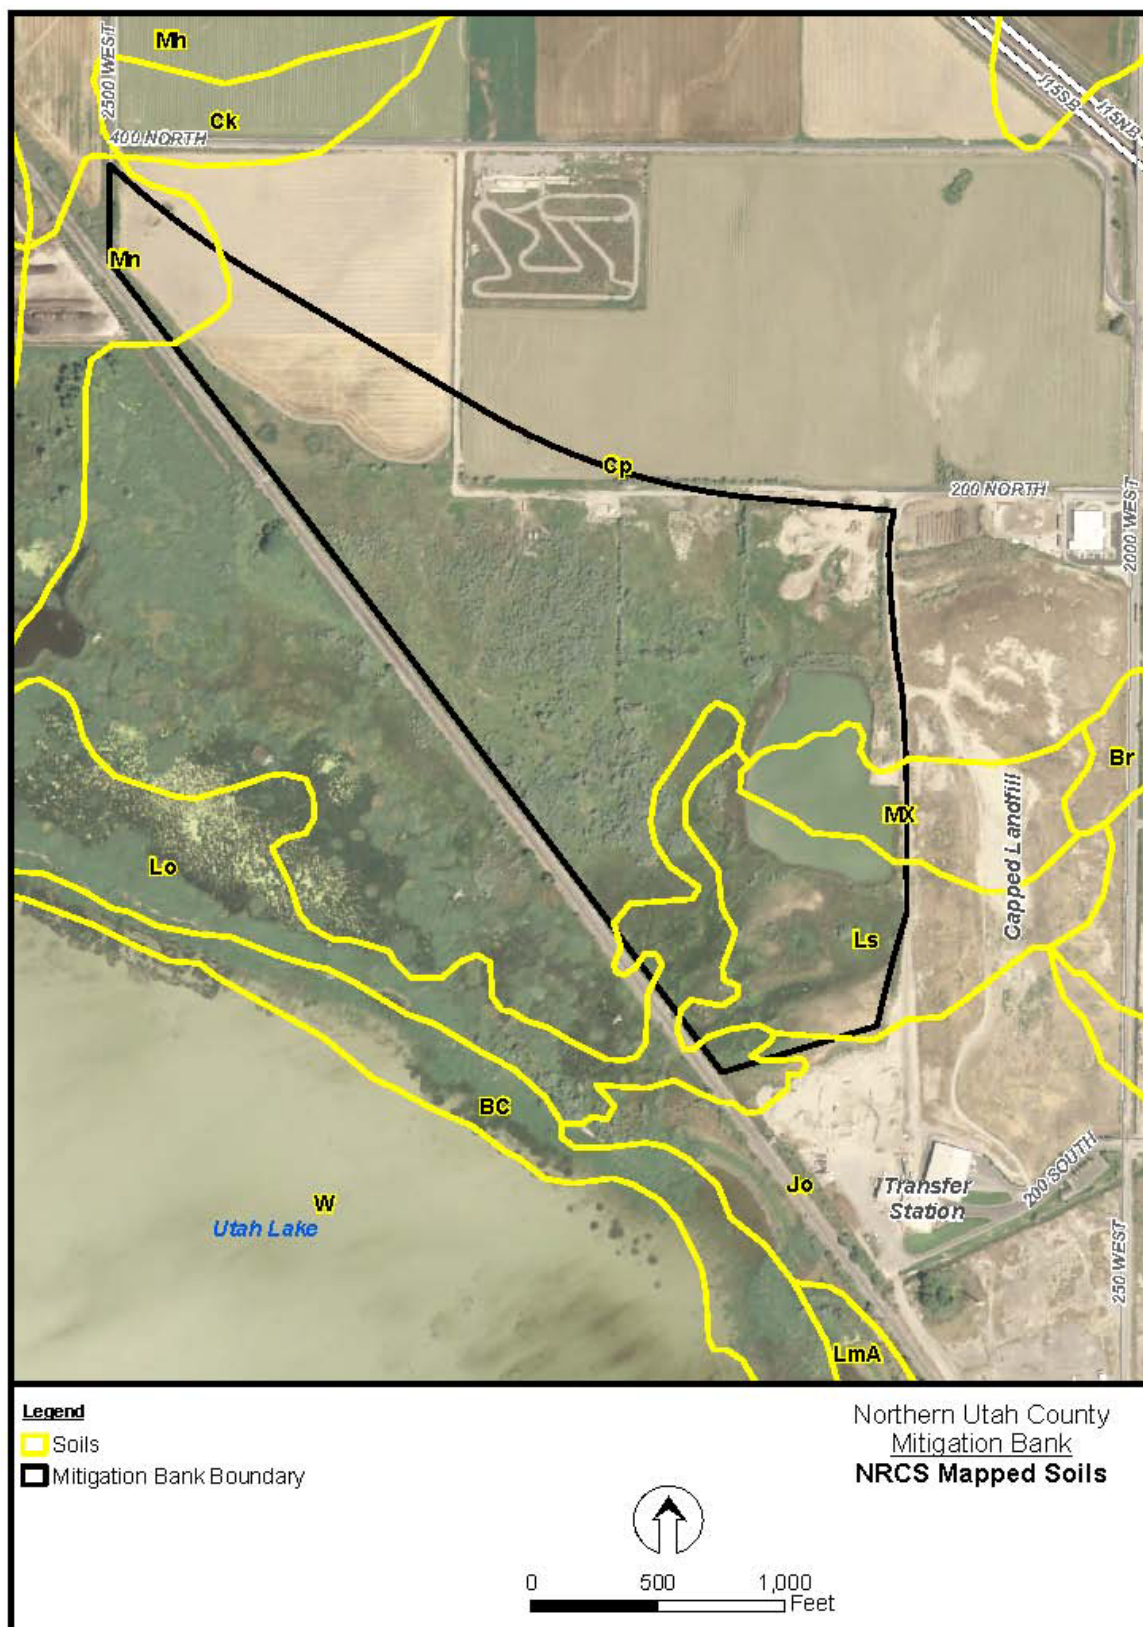
Figure 6. NRCS Mapped Soils

Hydric soils that are mapped within the Bank site include and are shown on Figure 6:

- Cp - Chipman-McBeth Complex
- Lo - Logan Silty Clay Loam
- Ls - Logan Silty Clay Loam, Heavy Variant
- MX - Mixed Alluvial Land, Saline
- Jo - Jordan Silt Loam

The soils on the Lindon site are all mapped as hydric, which provides adequate soil composition for wetland development. Once livestock and horse grazing is removed and soil compaction is reduced, normal water infiltration and capillary action can be restored. In most years, the soil is partially saturated for a period of two to six months.
